*Conservation of*  
**THE EID MISKIIY,**  
**MALE'**  
Republic of Maldives  
**2006**

# Project Report

# **Conservation of *Eid Miskiiy Male'*, Republic of Maldives**

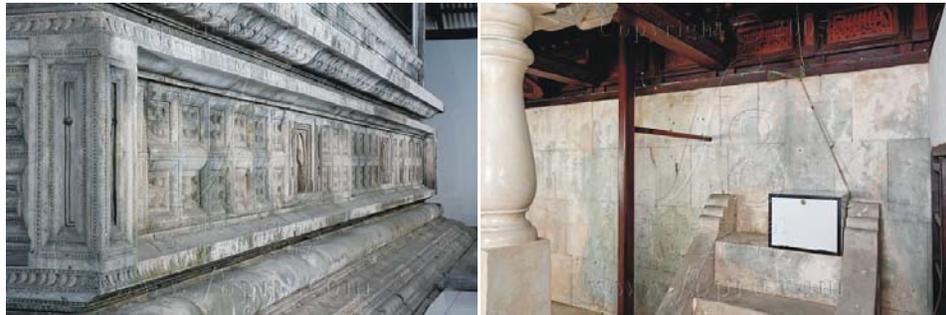
Coral stone was profusely infested with algal growth. The outer sides of walls all around had very thick growth, which, at places, appeared black and had covered the carvings completely. Even the inner side of the walls were also affected by algal growth.

The Coral stone being highly porous and pore diameter being moderately large, the algae had penetrated deep inside the pores, which appeared unsightly. Moreover, the organic acids liberated by the biological growths were further damaging the coral stone.

Though no living insect activity was observed, *Termicide* solution mixed with 2% solution of Pentachlorophenol in ethanol was used for dis-infection and eradication of insect and fungus activity on wood. Spray of 1% aqueous solution of Benzalkoniumchloride was used for the dis-infection and eradication of algal growth on coral stone.

Removal of algae from the coral surface was not a serious problem, but the algae that had penetrated inside the pores, was posing difficulty in its removal. The algae present inside the pores were removed using a jet of water at a suitable pressure. The water pressure of 4 kg/cm<sup>2</sup> was enough to clean the surface in most cases. To see the effect of water jet on the surface of the stone, NRLC while working for the conservation of Hukuru Miskiiy of Fenfushi Island, carried out the surface roughness studies on coral stone samples before and after the cleaning with water jet, and it was observed that there was no measurable erosion of the coral stone surface at the above mention water pressure, used for short durations just sufficient to clean the surface.

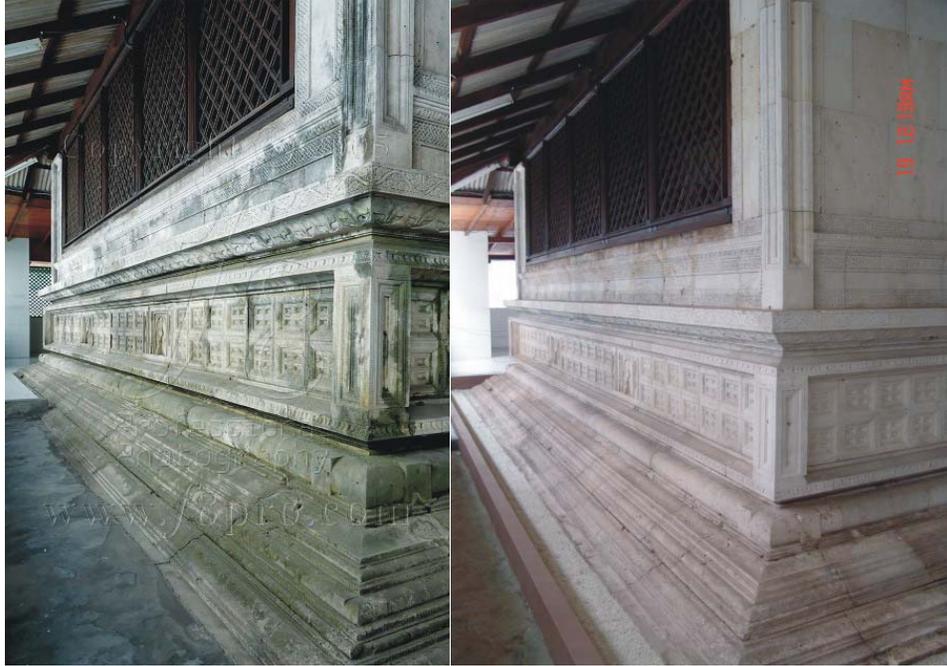
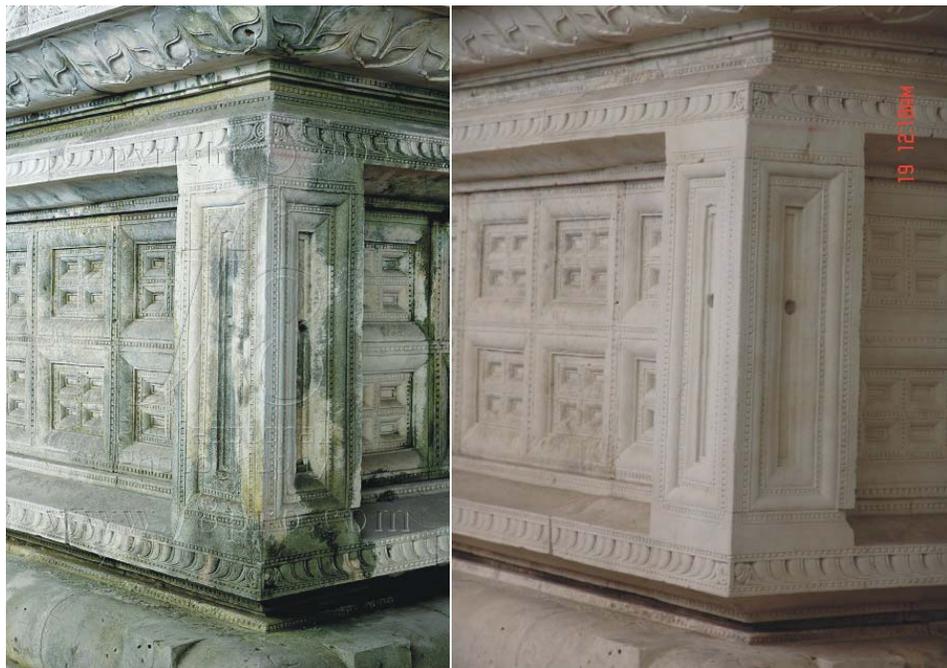
The monument got conserved to the fullest satisfaction of the conservators, which can be roughly assessed from the picture of the mosque before and after conservation. Cleaning and development of the surroundings along with interior decoration of the floor, will further improve the appearance of the mosque.
