*Conservation of*  
**THE EID MISKIIY,**  
**MALE'**  
Republic of Maldives  
**2006**

# Project Report

# **Conservation of *Eid Miskiiy Male'*, Republic of Maldives**

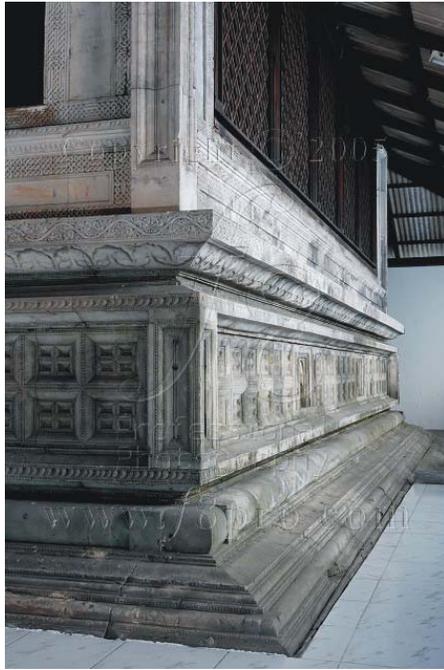
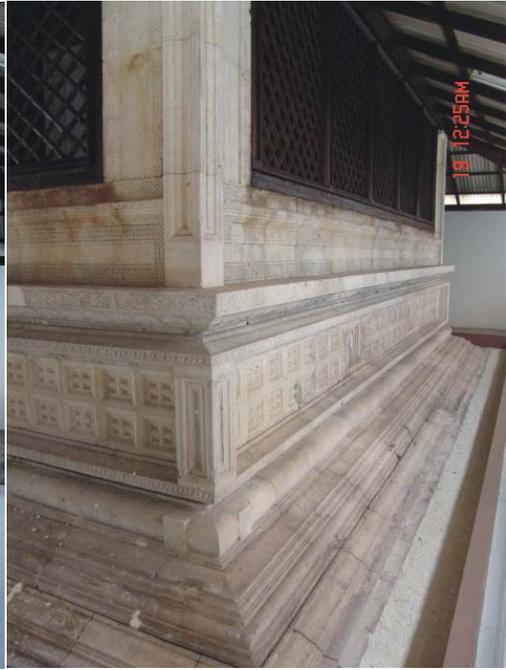
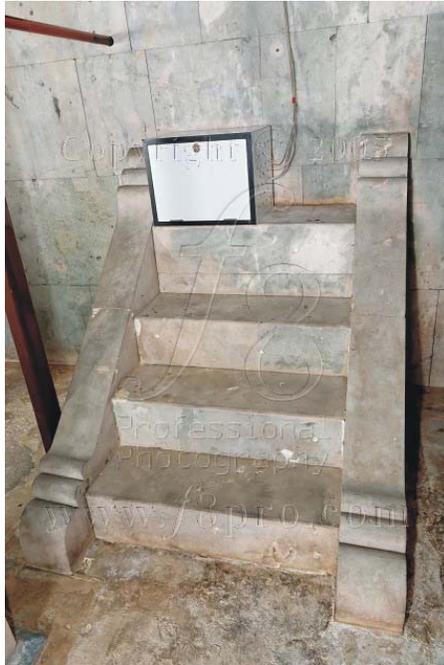
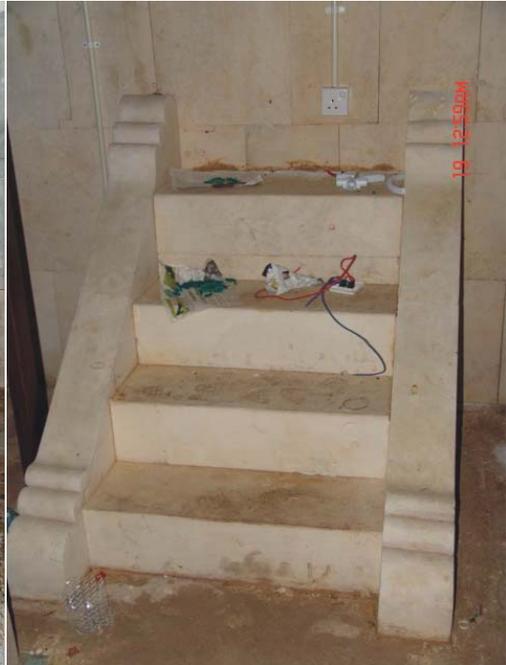
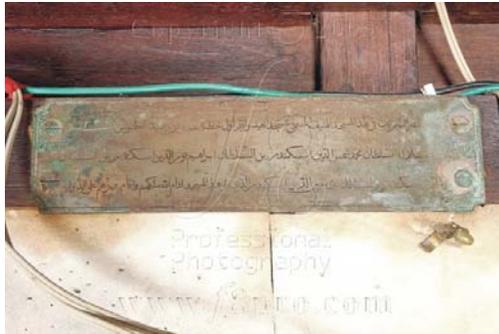
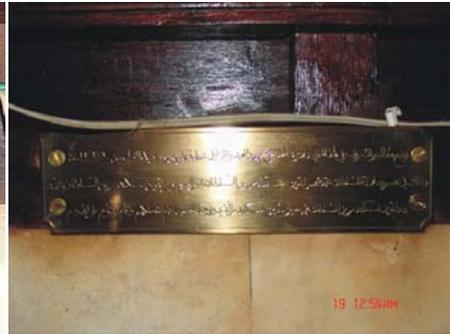
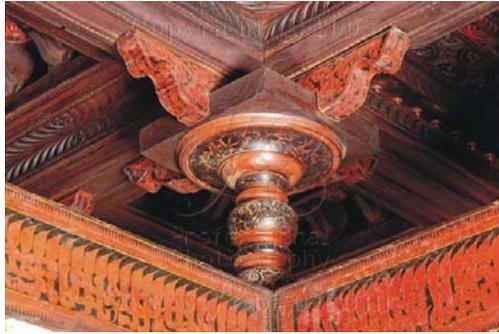
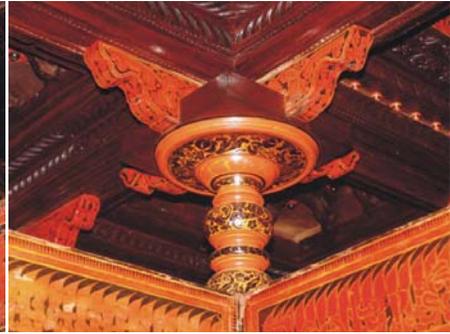
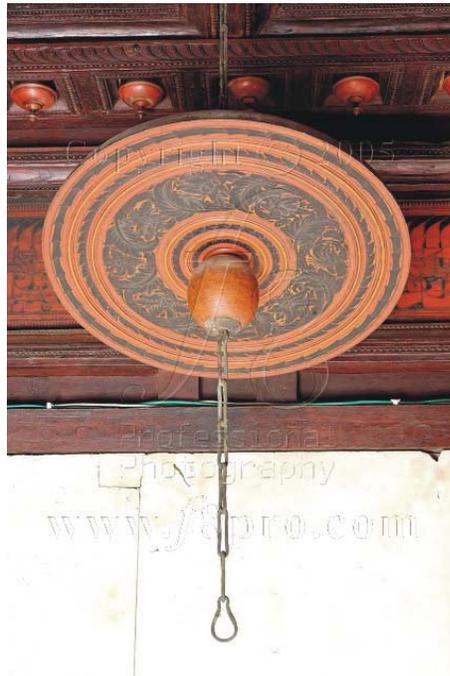
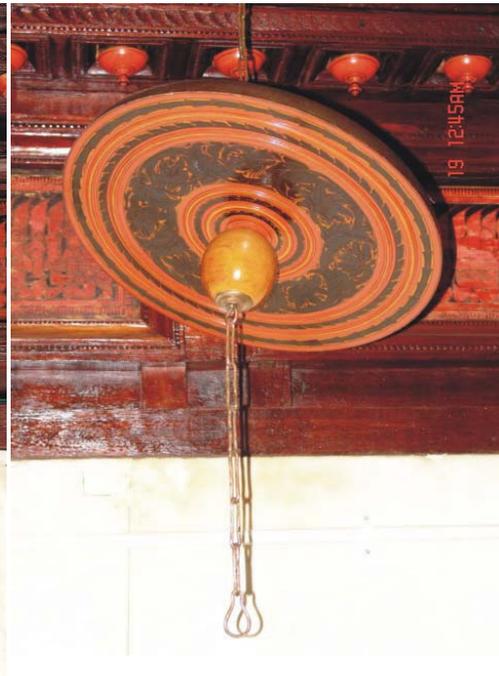
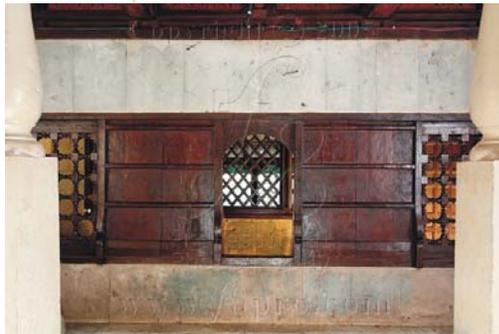
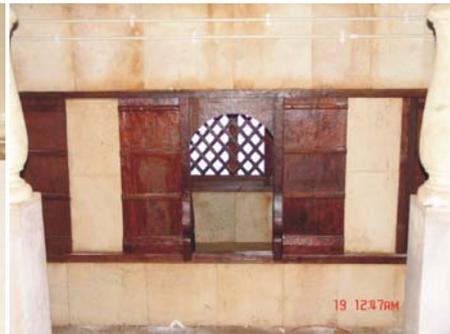
The monument got conserved to the fullest satisfaction of the conservators, which can be roughly assessed from the picture of the mosque before and after conservation. Cleaning and development of the surroundings along with interior decoration of the floor, will further improve the appearance of the mosque.
